Debris/Ice/TPS Assessment And Photographic Analysis For Shuttle Mission STS-43

September 1991

DEBRIS/ICE/TPS ASSESSMENT
AND
PHOTOGRAPHIC ANALYSIS
OF
- SHUTTLE MISSION STS-43

August 2, 1991

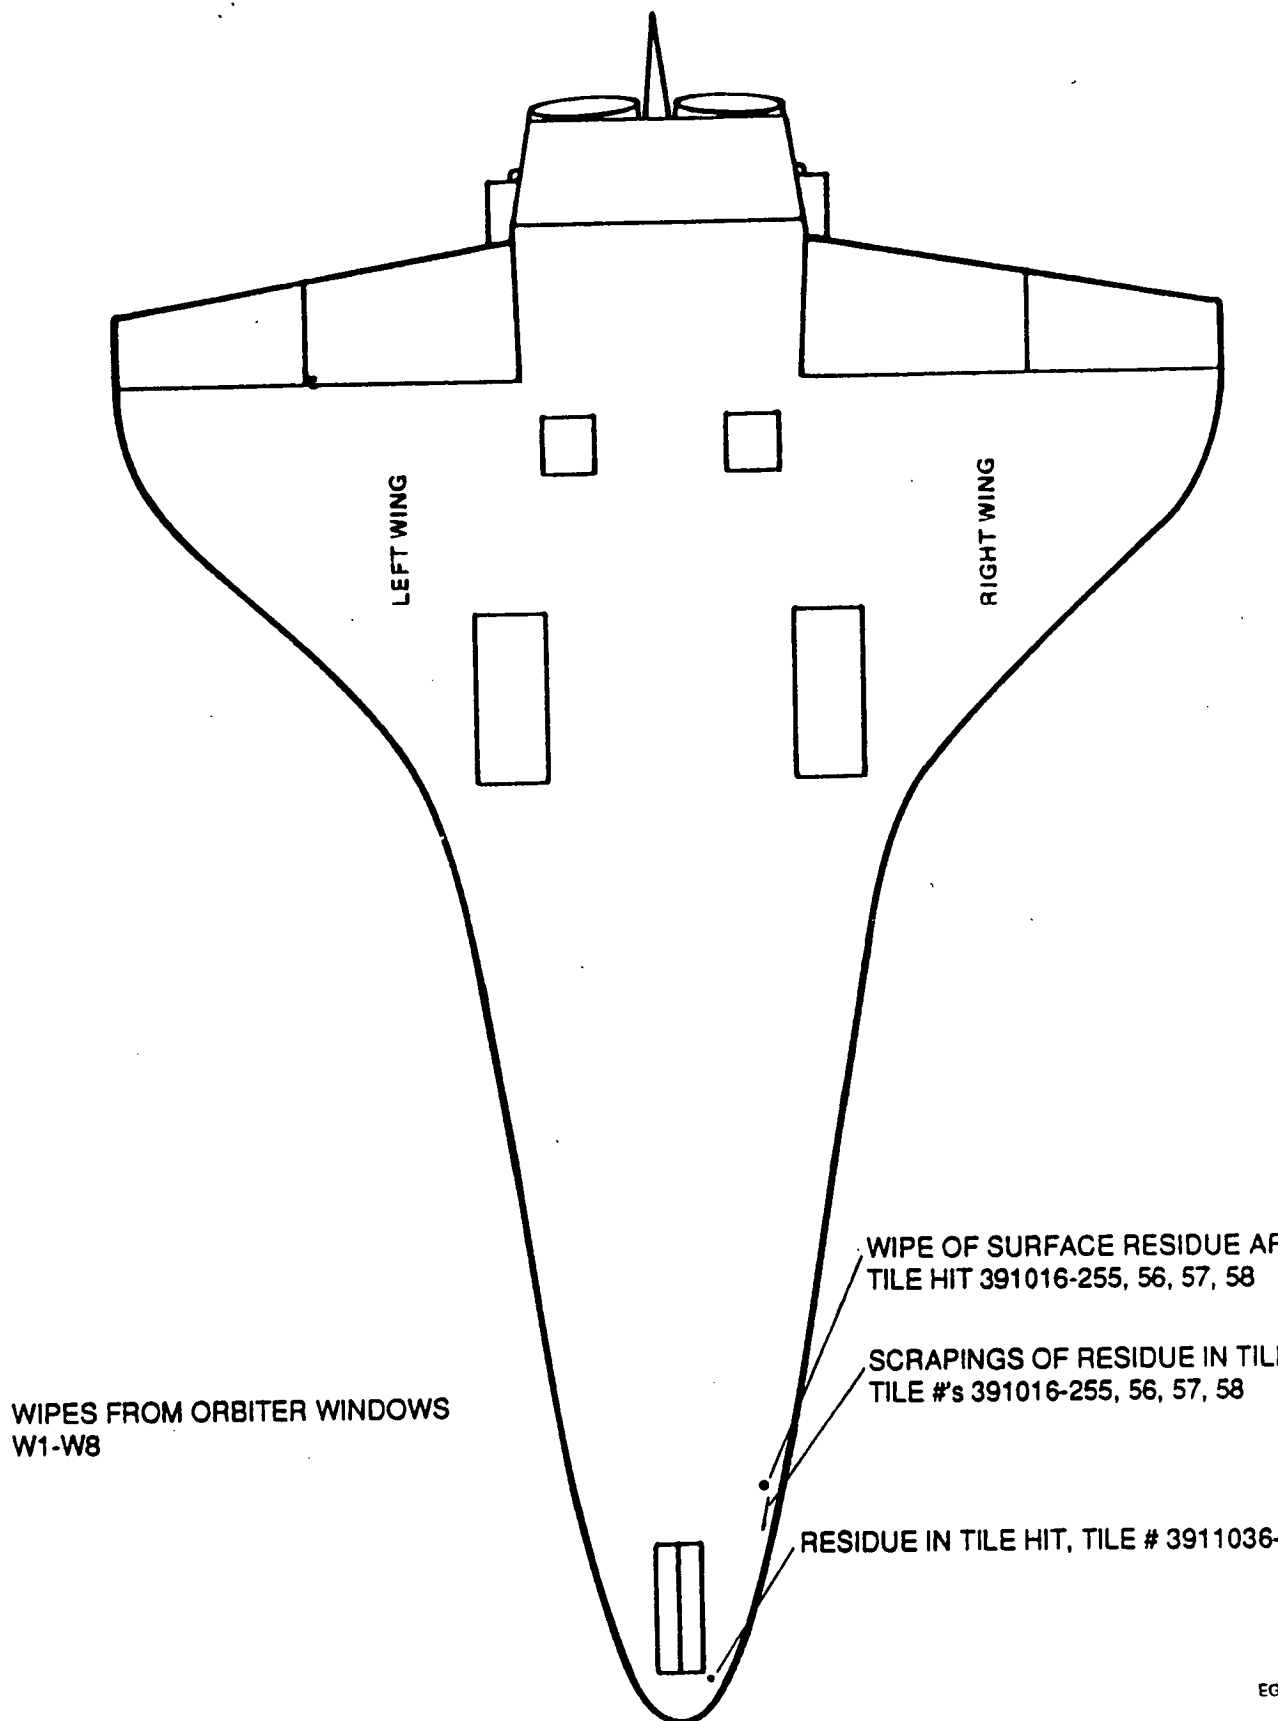
FIGURE 19. **STS-43**
CHEMICAL SAMPLE LOCATIONS

Orbiter windows #3 and #4 exhibited moderate to heavy hazing with a few small streaks. Windows #1, #2, #5, and #6 had light to moderate hazing with several small streaks. There was no evidence that the haze on the windows was the result of flight through volcanic ash. Figure 19 shows the sites on the Orbiter where samples were taken for laboratory analysis.

A total of 12 samples were obtained from Orbiter OV-104 during the STS-43 post landing debris assessment at Kennedy Space Center, Florida (Figure 19). The 12 submitted samples consisted of 8 Orbiter window wipes (W1-8), 3 tile residue samples, and 1 debris sample from the runway. The samples were analyzed by the NASA KSC Microchemical Analysis Branch (MAB) for material composition and comparison to known STS materials. The specific elemental analysis is shown in the appended MAB report. Debris analysis involves the placing and correlating of particles with respect to composition, thermal (mission) effects, and availability. Debris sample results and analyses are listed by Orbiter location in the following summaries.

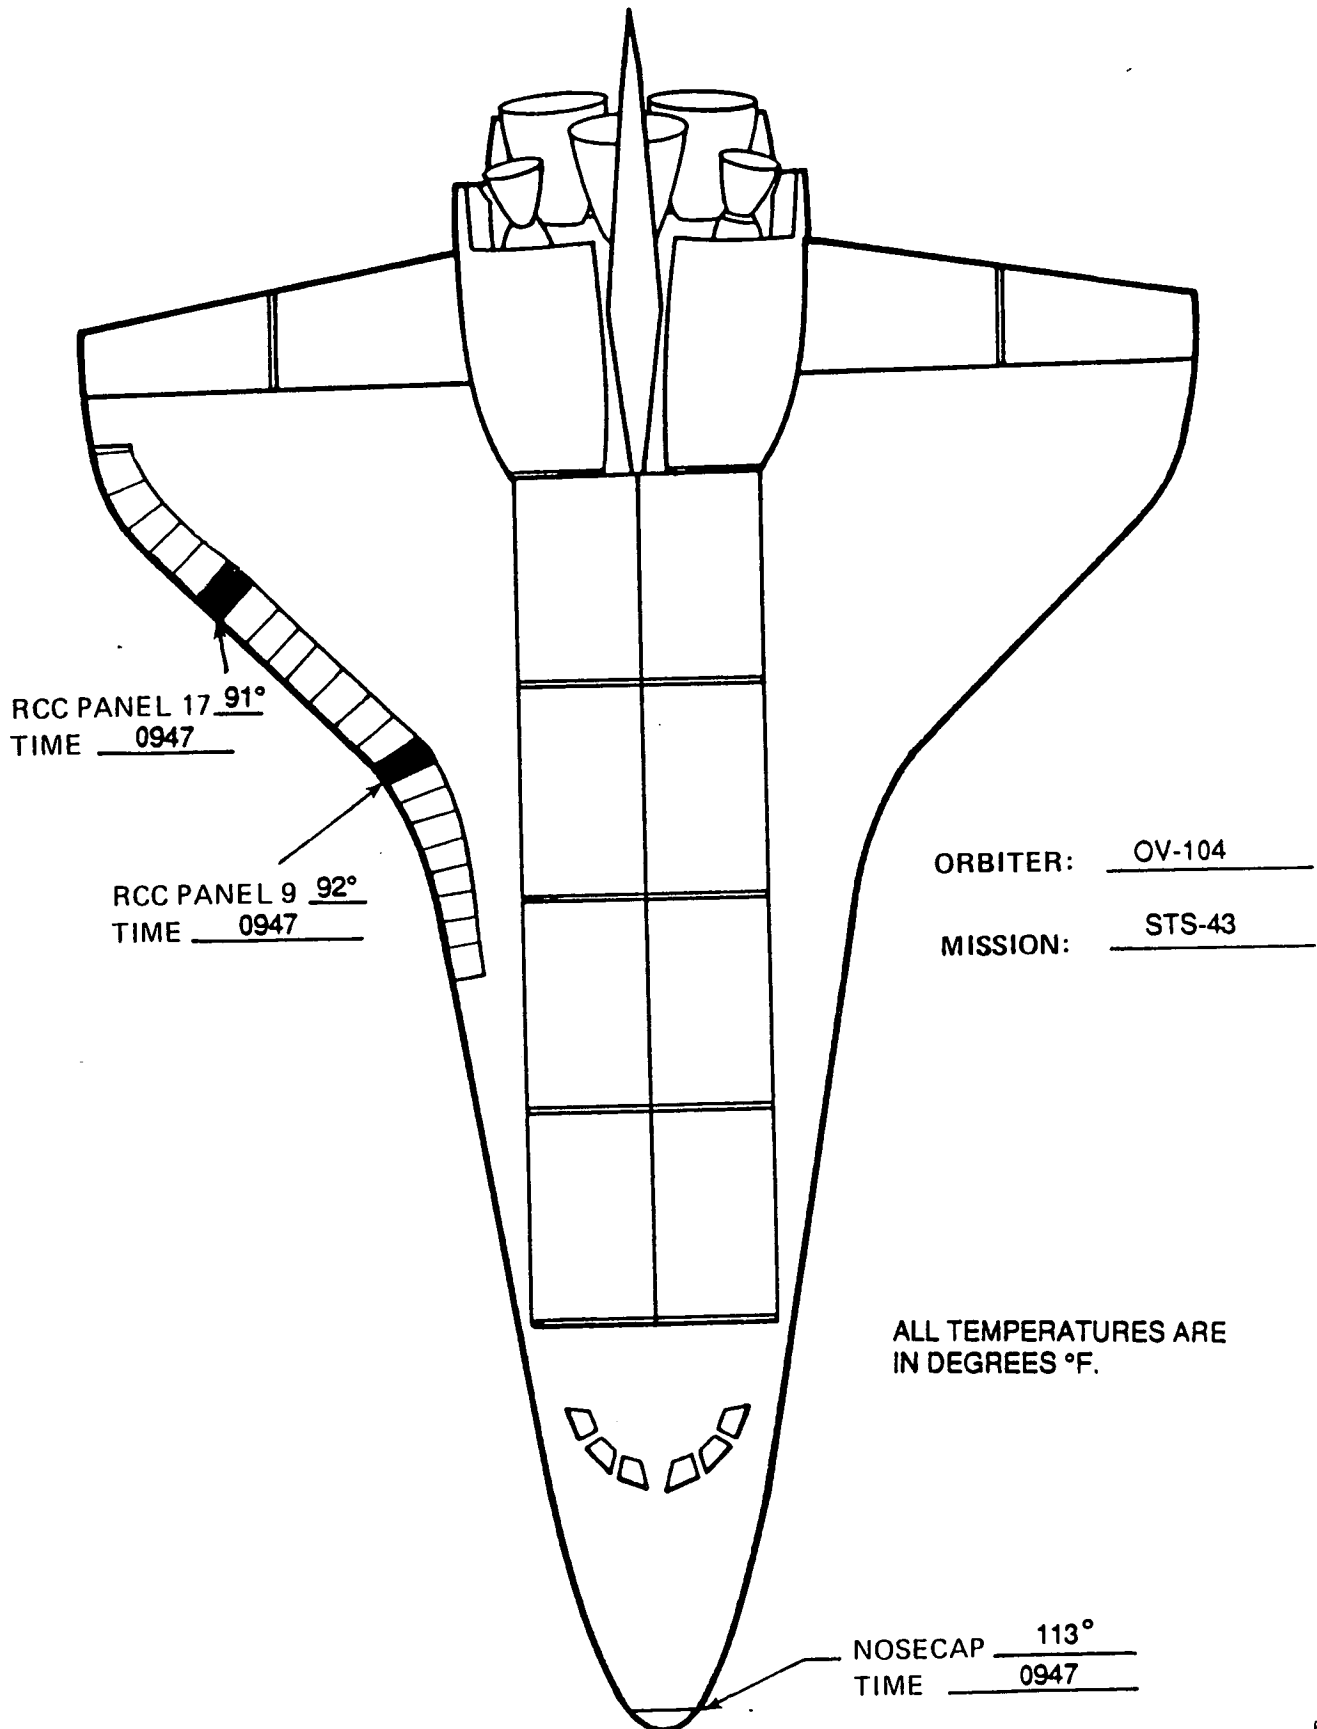
FIGURE 20. **STS-43**
TEMPERATURE MEASUREMENTS

The Mikron infrared radiometer was used to measure the surface temperatures of several areas on the Orbiter. Eighty-four minutes after landing, the noscap RCC was 113 degrees F, the RH wing leading edge RCC panel #9 was 92 degrees F, and the RH wing panel #17 was 91 degrees F (Figure 20).

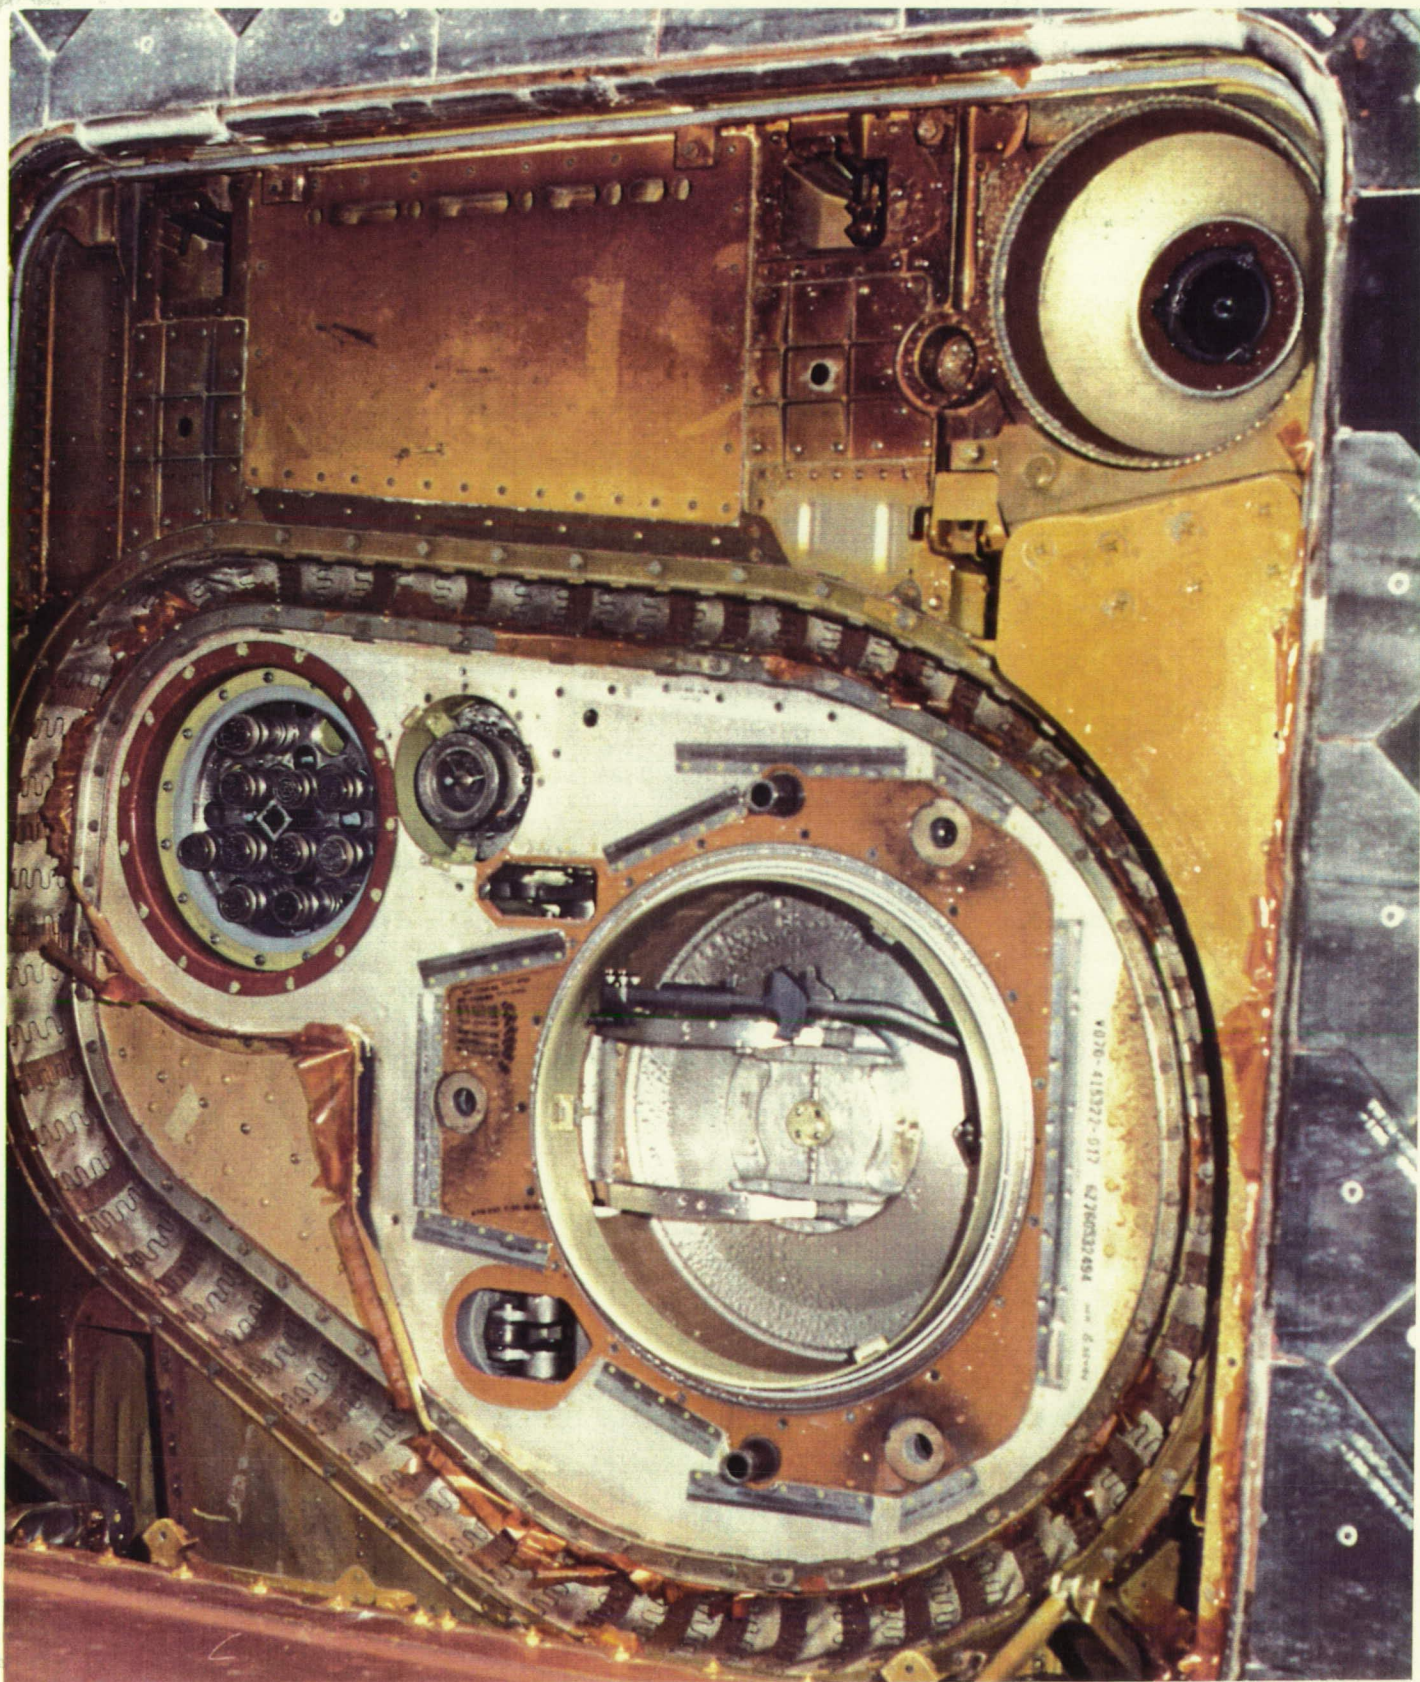
Overall view of the L02 ET/ORB umbilical. The separation ordnance device debris plunger in EO-3 was seated and appeared to have functioned properly. There was no significant heat intrusion past the ET door thermal barrier.

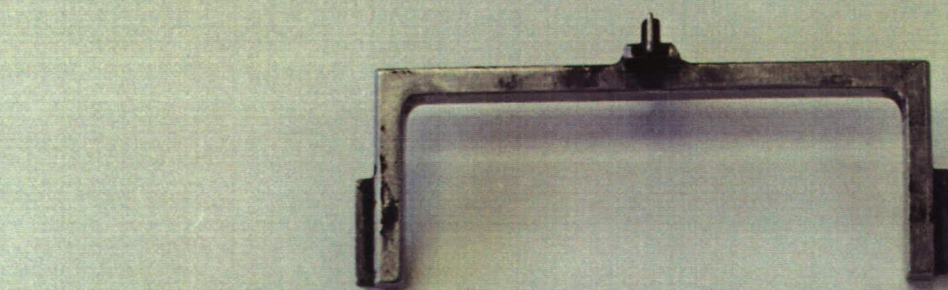
A metallic U-shaped object, identified as a V072-565471-001 yoke, was found on the runway beneath the LO2 ET/ORB umbilical and originated from the forward inboard umbilical separation bolt head.

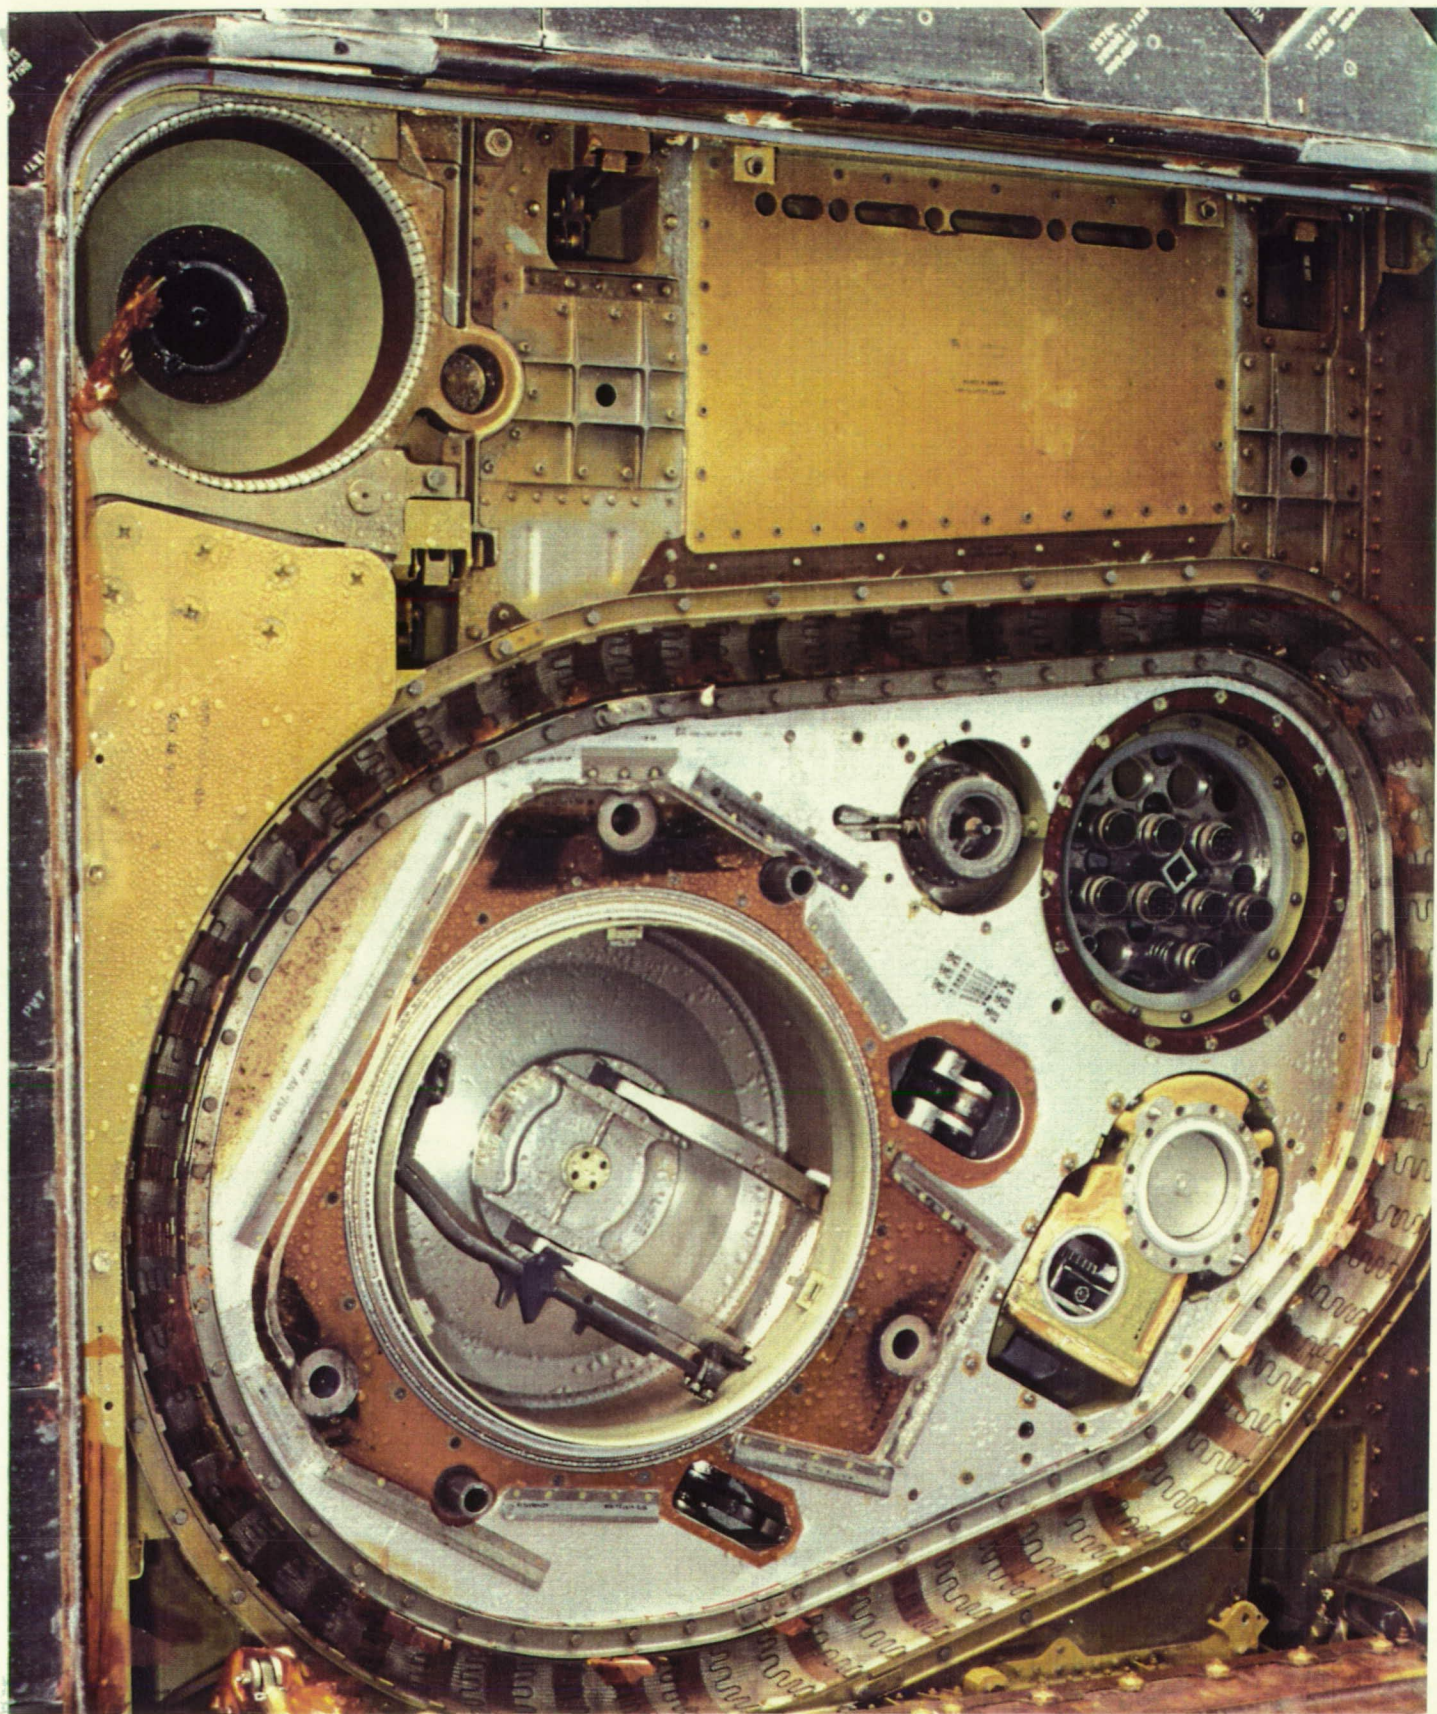
Overall view of the LH2 ET/ORB umbilical. The separation ordnance debris plunger in EO-2 was seated and appeared to have functioned properly. There was no significant heat intrusion past the ET door thermal barrier.
